TECHNICAL PROCEDURE

INTRAAX®

SUBJECT: Shock Mount Assembly Procedure

LIT NO: L635

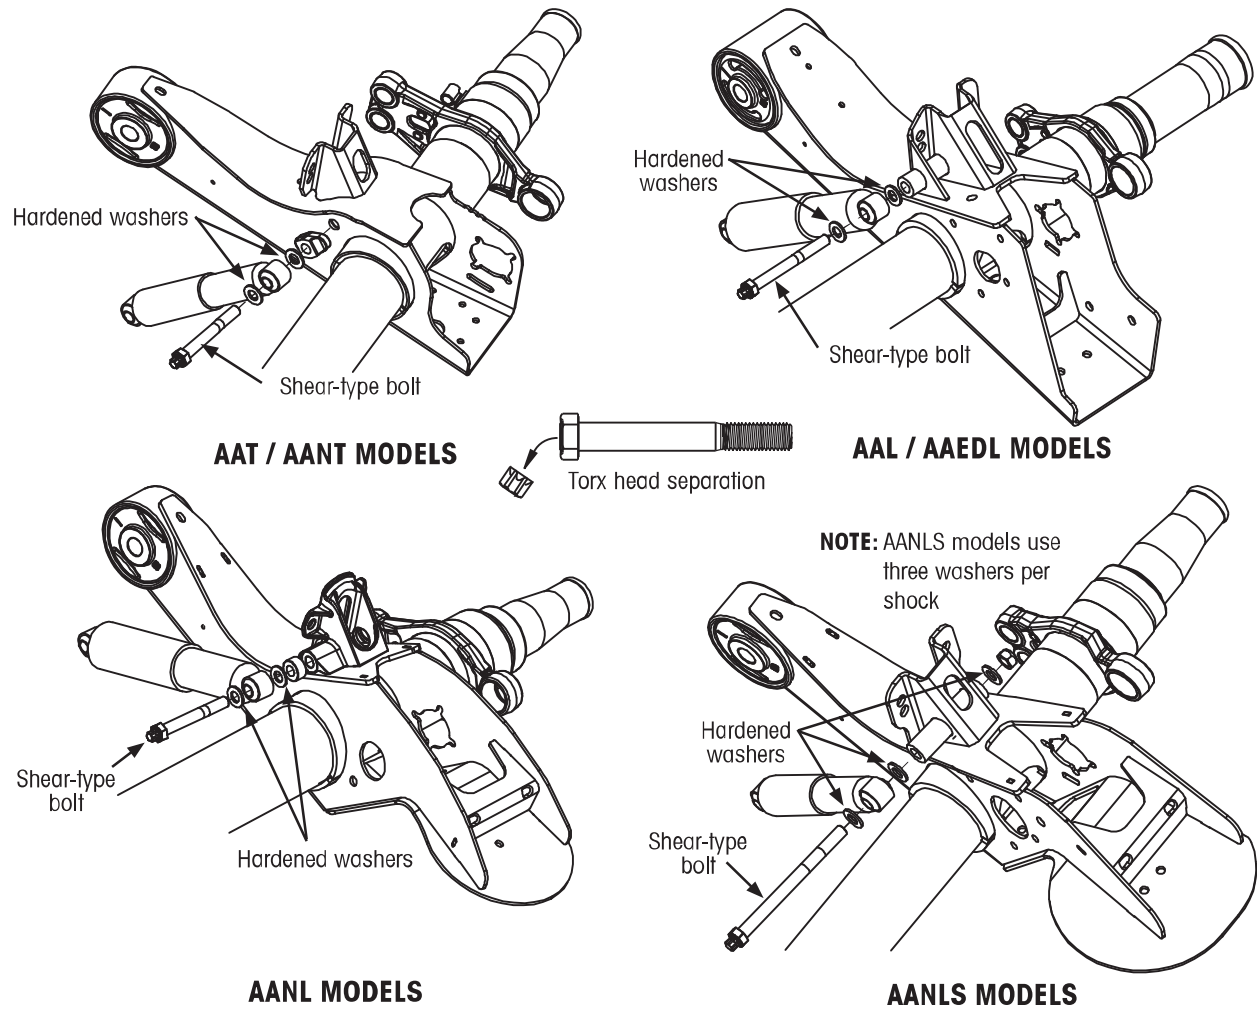
Figure 1: Lower shock mount assembly on suspensions without shock straps

Hendrickson uses a shear-type bolt in the lower shock absorber connection. To obtain the proper clamp load, install hardened washers on each side of the shock absorber bushing (Figure 1), or install the shock strap clevis (Figure 2), and tighten the shear-type bolt until the bolt's Torx head shears off. Use an E20 Torx socket to tighten and shear the bolt. Torx head separation occurs between 200 and 240 ft. lbs. (271 and 325 N•m) of torque.

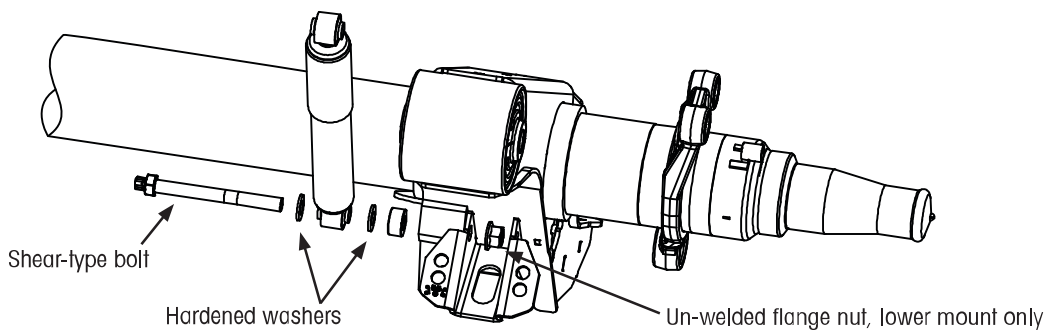
Figure 2: AAL lower shock mount with LDA axle

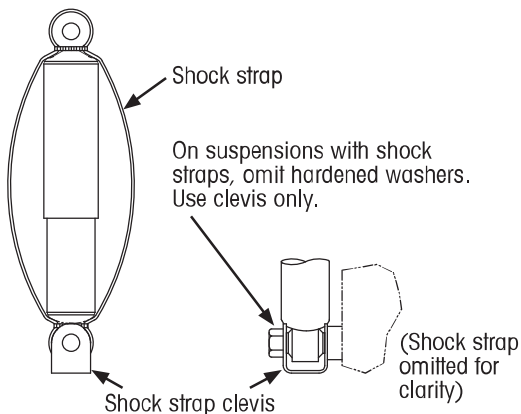
Figure 3: Lower shock mount assembly on suspensions with shock straps

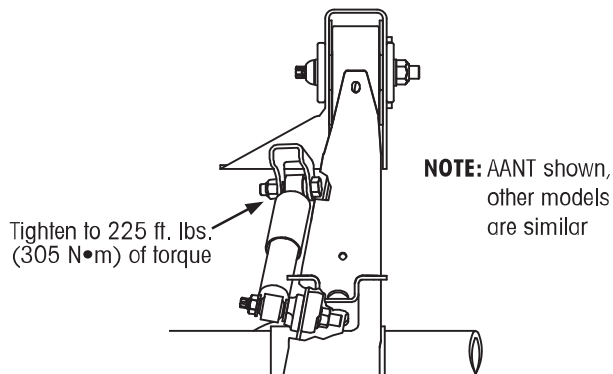
Figure 4: Upper shock mount assembly

The upper shock mount is tightened to 225 ft. lbs. (305 N•m) of torque (Figure 4).

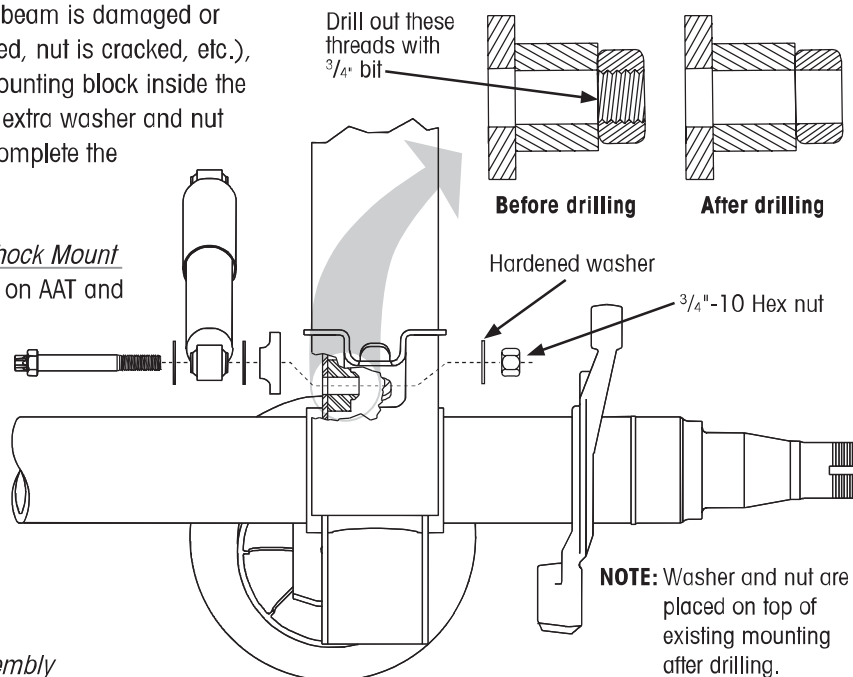
Figure 5: Damaged thread hardware assembly

If the nut on the inside of the suspension beam is damaged or cannot be reused (i.e., threads are stripped, nut is cracked, etc.), drill out the threads in the lower shock mounting block inside the suspension beam (Figure 5) and use the extra washer and nut provided in the shock bolt service kit to complete the lower shock mount.
