RECOGNIZING & CORRECTING BRAKING PROBLEMS

The following information deals with brake drum related problems, probable causes and possible solutions. This information is intended as a guide to help truck operators and service persons recognize brake drum and brake drum related problems. It offers suggestions to help correct those problems. It is not intended as a complete service guide. The information is based on reasonable probabilities. The described corrections are those most frequently used by Motor Wheel service engineers. The solutions/corrections given are those commonly used successfully. All brake system service work should be performed by a qualified brake mechanic.

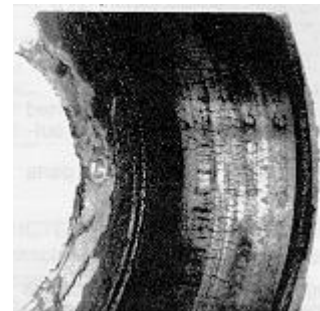
5.0 Grease Stained Drums

5.1 Condition:

Discolored spots on the braking surface; the back and other parts of the drum will usually be covered with oil or grease. Oil or grease soaked brake lining and drum can reduce the amount of stopping friction, causing the other drums on the vehicle to work harder. This situation causes drum overheating, brake fade and, eventually, drum failure.

Over greasing the brake camshaft bushing, worn camshaft bushings, or leaking oil seal are usually the causes of this condition.

Clean the brake drum and all adjacent metal brake parts with solvent. Replace faulty oil seals and remove excess grease from the camshaft. If brake lining is saturated with oil or grease, replace.

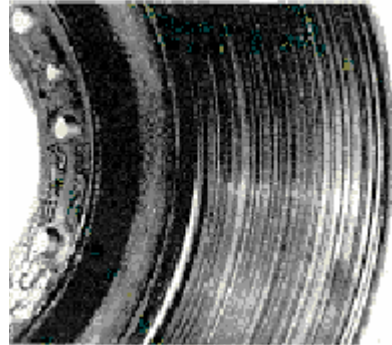
6.0 Scored Drums

6.1 Condition:

Drum will have medium to deep grooves around the circumference of the braking surface. Brake lining will show a similar wear pattern. Foreign metal particles can usually be found embedded in the lining.

Scoring or rapid wear can often be traced to an unbalanced brake system. Incompatibility between the drum and lining can also be a cause. Abrasive material such as sand, grit, metal chips, etc., present in the drum interior or embedded in the lining might be a cause.

Consult with drum and lining manufacturers for drum and lining compatibility recommendations. If brake system is out of balance, make necessary corrections and adjustments. Scored drums may be machined within recommended tolerances. (See BRAKE DRUM MACHINING section.)
