RECOGNIZING & CORRECTING BRAKING PROBLEMS

The following information deals with brake drum related problems, probable causes and possible solutions. This information is intended as a guide to help truck operators and service persons recognize brake drum and brake drum related problems. It offers suggestions to help correct those problems. It is not intended as a complete service guide. The information is based on reasonable probabilities. The described corrections are those most frequently used by Motor Wheel service engineers. The solutions/corrections given are those commonly used successfully. All brake system service work should be performed by a qualified brake mechanic.

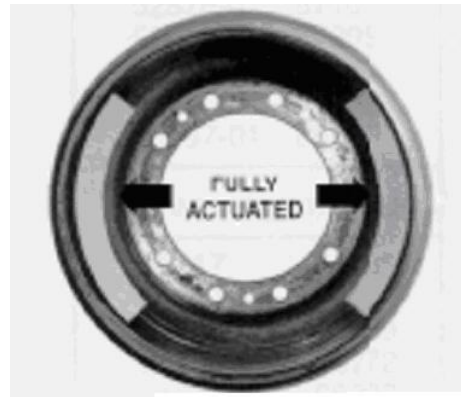
Excessive heat build-up in the drum and lining lead to "fade".

Heat build-up can change the friction quality of the brake lining and the drum. The friction coefficient between the lining and drum is reduced causing too much slip- not enough grip.

There can also be mechanical deflection in the system. Excessive heat build-up can also cause drums to expand past the point of maximum brake shoe travel. Linings will no longer properly contact the braking surface and "fade" may be the result.

1. Check the air pressure delivery system to be certain the system is in balance. Each brake on the vehicle must be doing its appropriate share of the work.
2. Look for the problems in the foundation brake. Inspect for proper brake adjustment.
3. Inspect drums. Look for the following conditions:
 - a. Out-of-round braking surface
 - b. Bell mouth
 - c. Heat spots
 - d. Polished braking surface

4. Measure inside diameter to be certain drums have not been over machined (working surface diameter re-machined beyond manufacturer's recommendation), or worn beyond usable limits. (See BRAKE DRUM MACHINING section)

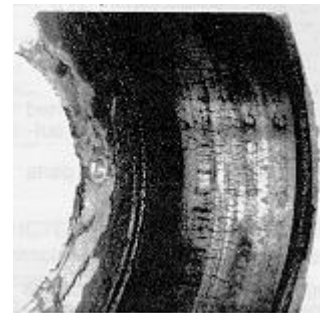
5.0 Grease Stained Drums

Discolored spots on the braking surface; the back and other parts of the drum will usually be covered with oil or grease. Oil or grease soaked brake lining and drum can reduce the amount of stopping friction, causing the other drums on the vehicle to work harder. This situation causes drum overheating, brake fade and, eventually, drum failure.

Over greasing the brake camshaft bushing, worn camshaft bushings, or leaking oil seal are usually the causes of this condition.

Clean the brake drum and all adjacent metal brake parts with solvent. Replace faulty oil seals and remove excess grease from the camshaft. If brake lining is saturated with oil or grease, replace.

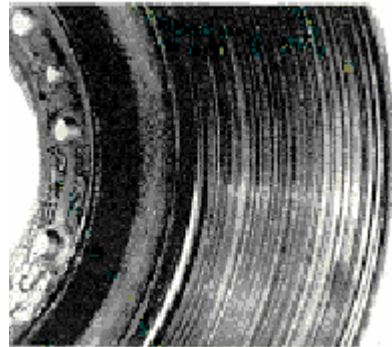
6.0 Scored Drums

Drum will have medium to deep grooves around the circumference of the braking surface. Brake lining will show a similar wear pattern. Foreign metal particles can usually be found embedded in the lining.

Scoring or rapid wear can often be traced to an unbalanced brake system. Incompatibility between the drum and lining can also be a cause. Abrasive material such as sand, grit, metal chips, etc., present in the drum interior or embedded in the lining might be a cause.

Consult with drum and lining manufacturers for drum and lining compatibility recommendations. If brake system is out of balance, make necessary corrections and adjustments. Scored drums may be machined within recommended tolerances. (See BRAKE DRUM MACHINING section.)

If road contaminants are present, install dust shield. If dust shield is holding particles in, then remove the lower half of the shield for a trial period.
